## **Determination of Deformations of a High-Capacity Tank Using the Technology of Terrestrial Laser Scanning**

**Keywords:** terrestrial laser scanning, deformation analysis, high-capacity tank

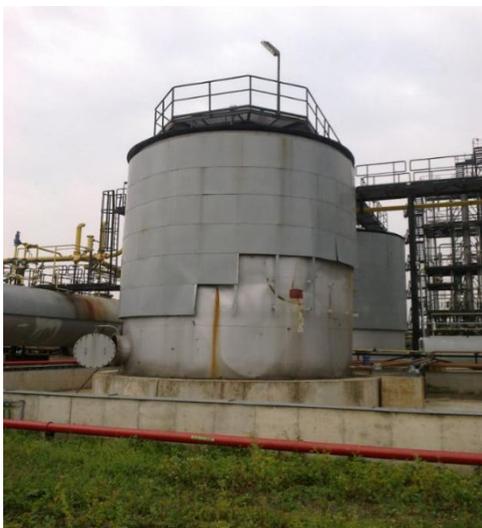
**Fig. 1: The High-Capacity Tank in the Východoslovenská Rafinéria, s.r.o.**

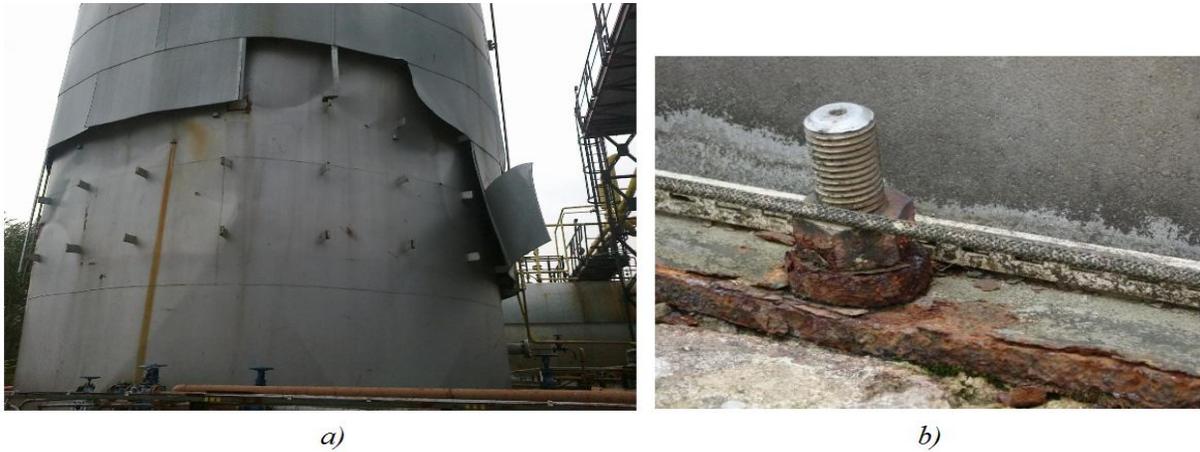
**Fig. 2: A) View of Places with the Largest Deformations; B) Display of Rips of the Tank Anchorage**

In the complex of Východoslovenská rafinéria, s.r.o., (distillation unit Senné) the survey of deformation extent was realized in June 2013. In order to change stored media, the tank was filled with hot water to a height of 2 meters in 2012. The main objective was the removal of sediments and residues of aromatics in the storage unit. After filling, the tank was hermetically sealed while there was a decrease of pressure due to condensation, leading to a collapse – the implosion of the tank caused by a violation of technological procedure. The tank was filled with water to a height of about 4 meters. The Fig. 1 and 2 shows the state of the tank after filling with water and places of water leak through cracks, incurred by the weakening of plastically deformed material, and are clearly visible.

By a subsequent control, also the anchorage of tank was documented and it was found that rips at three places were caused by the implosion. Material of the inner wall is damaged, but welded joints do not show damage. During the visual inspection of the tank in September 2012, the sample for metallographic study was taken and an ultrasonic thickness measurement was performed together with marking points of measurement. We have found the state of corrosion loss, which is not higher than 2%.

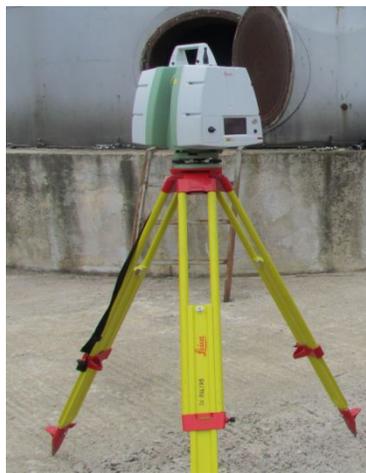
**Fig. 3: Terrestrial Laser Scanner Leica ScanStationC10**

Geodetic survey of the tank deformation was realized in June 2013 by terrestrial laser scanning using the Leica ScanStation C10 (Fig. 3, Tab. 2), that is a high-speed, full-panoramic pulse scanner. Because the tank deformation had to be measured from its interior, the spatial position of points was determined in a local coordinate system, with the origin at the center of the scanner at the first scanning station. For their calculation, the following equations (1, 2, 3) [6, 10] were used, where  $d$  is a slope distance,  $\omega$  is a horizontal angle and  $\zeta$  is a zenithal distance. The Leica ScanStation C10 can be described as a pulse full panoramic long-range scanner with the mean error of position determination 6 mm and distance measurement 4 mm. Density of the scanning grid was set to 2x2 mm so that the measured data represent the scanned surface as accurately as possible [3, 4].
